AN ASSESSMENT OF ABANDONED MINES IN NORTHERN SASKATCHEWAN

(YEAR 3)

An Assessment of Abandoned Mines in Northern Saskatchewan

File R3278 May 2003

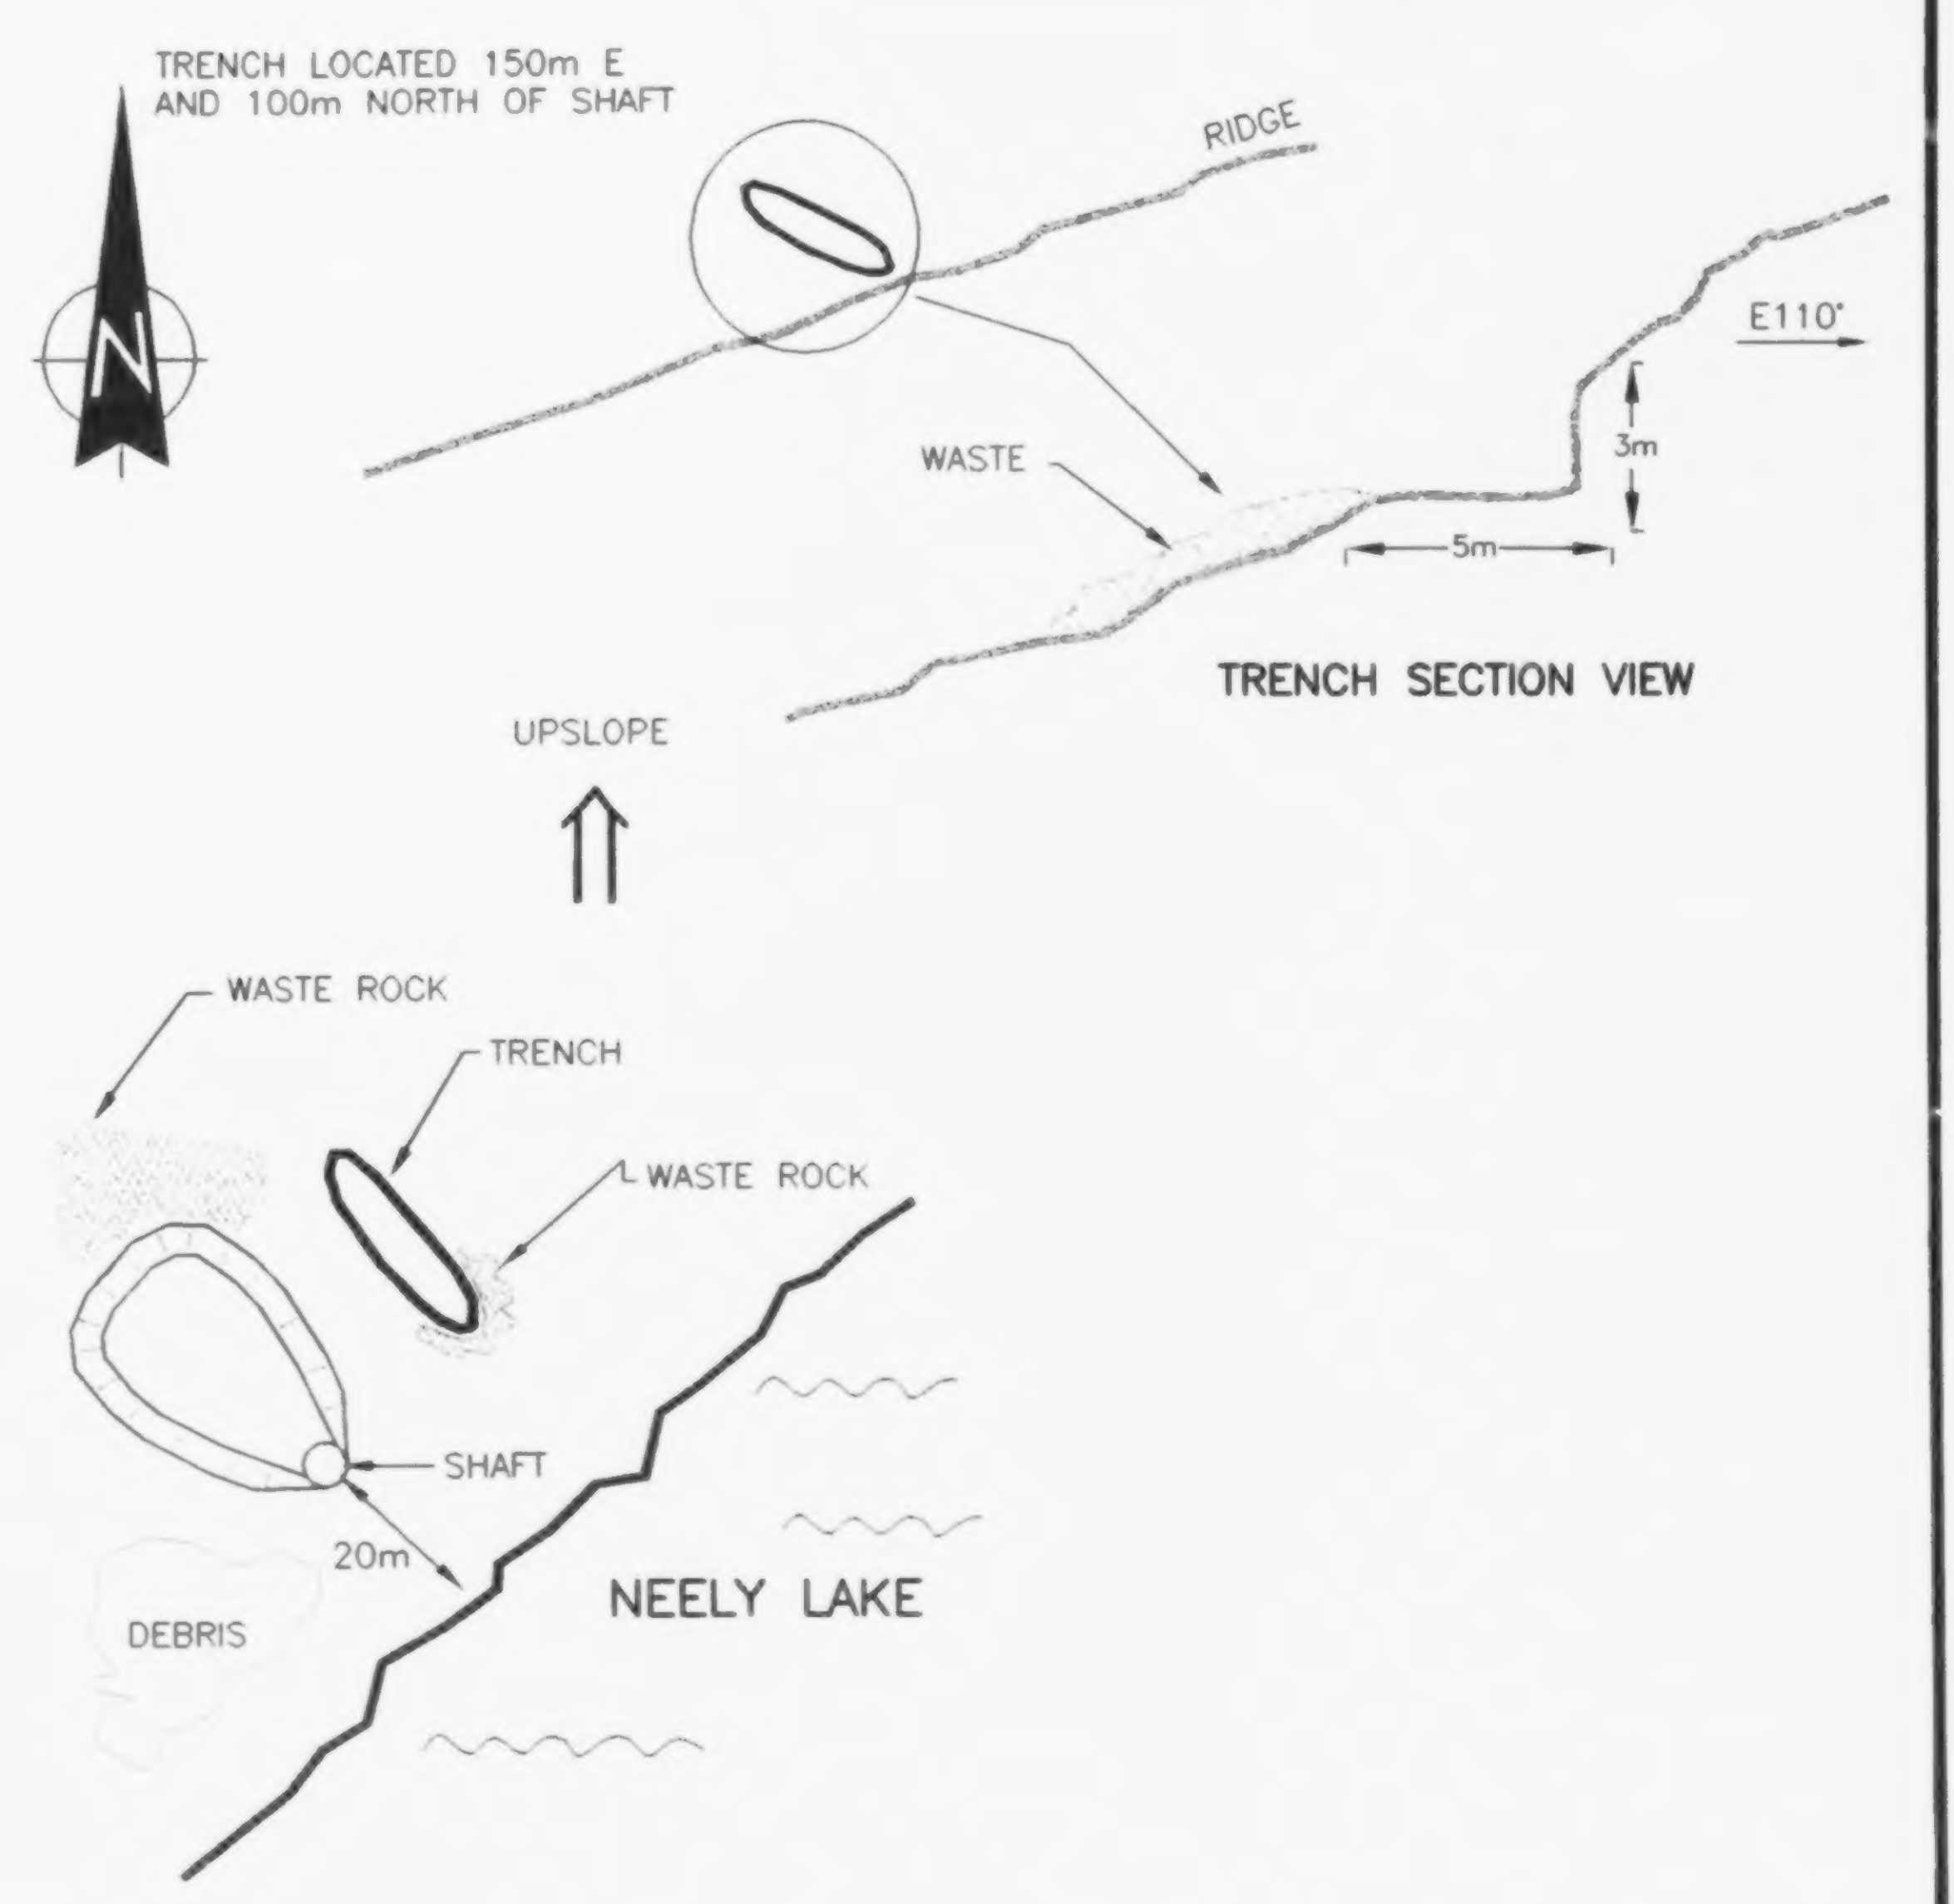
R3278/FIG6.1–2.DWG

TRENCH LOCATED 150m E
AND 100m NORTH OF SHAFT
N
RIDGE
E110°
3m
WASTE
5m
TRENCH SECTION VIEW
UPSLOPE
WASTE ROCK
TRENCH
WASTE ROCK
SHAFT
20m
DEBRIS
NEELY LAKE

Northeast of the shaft is a deep trench cut into a hillside. The trench faces a step 3 – 5 m drop exists from the hill-side to the bottom of the trench (Figure 6.1-2). The trench is about 10.15 m long and 3 m wide.

Follow-up work should include blasting the shaft closed or covering it with a secure concrete cap. Debris could be pushed into the shaft prior to sealing. Waste rock near the trench northeast of the shaft should be pushed into the trench to remove the fall hazard associated with the trench fall.

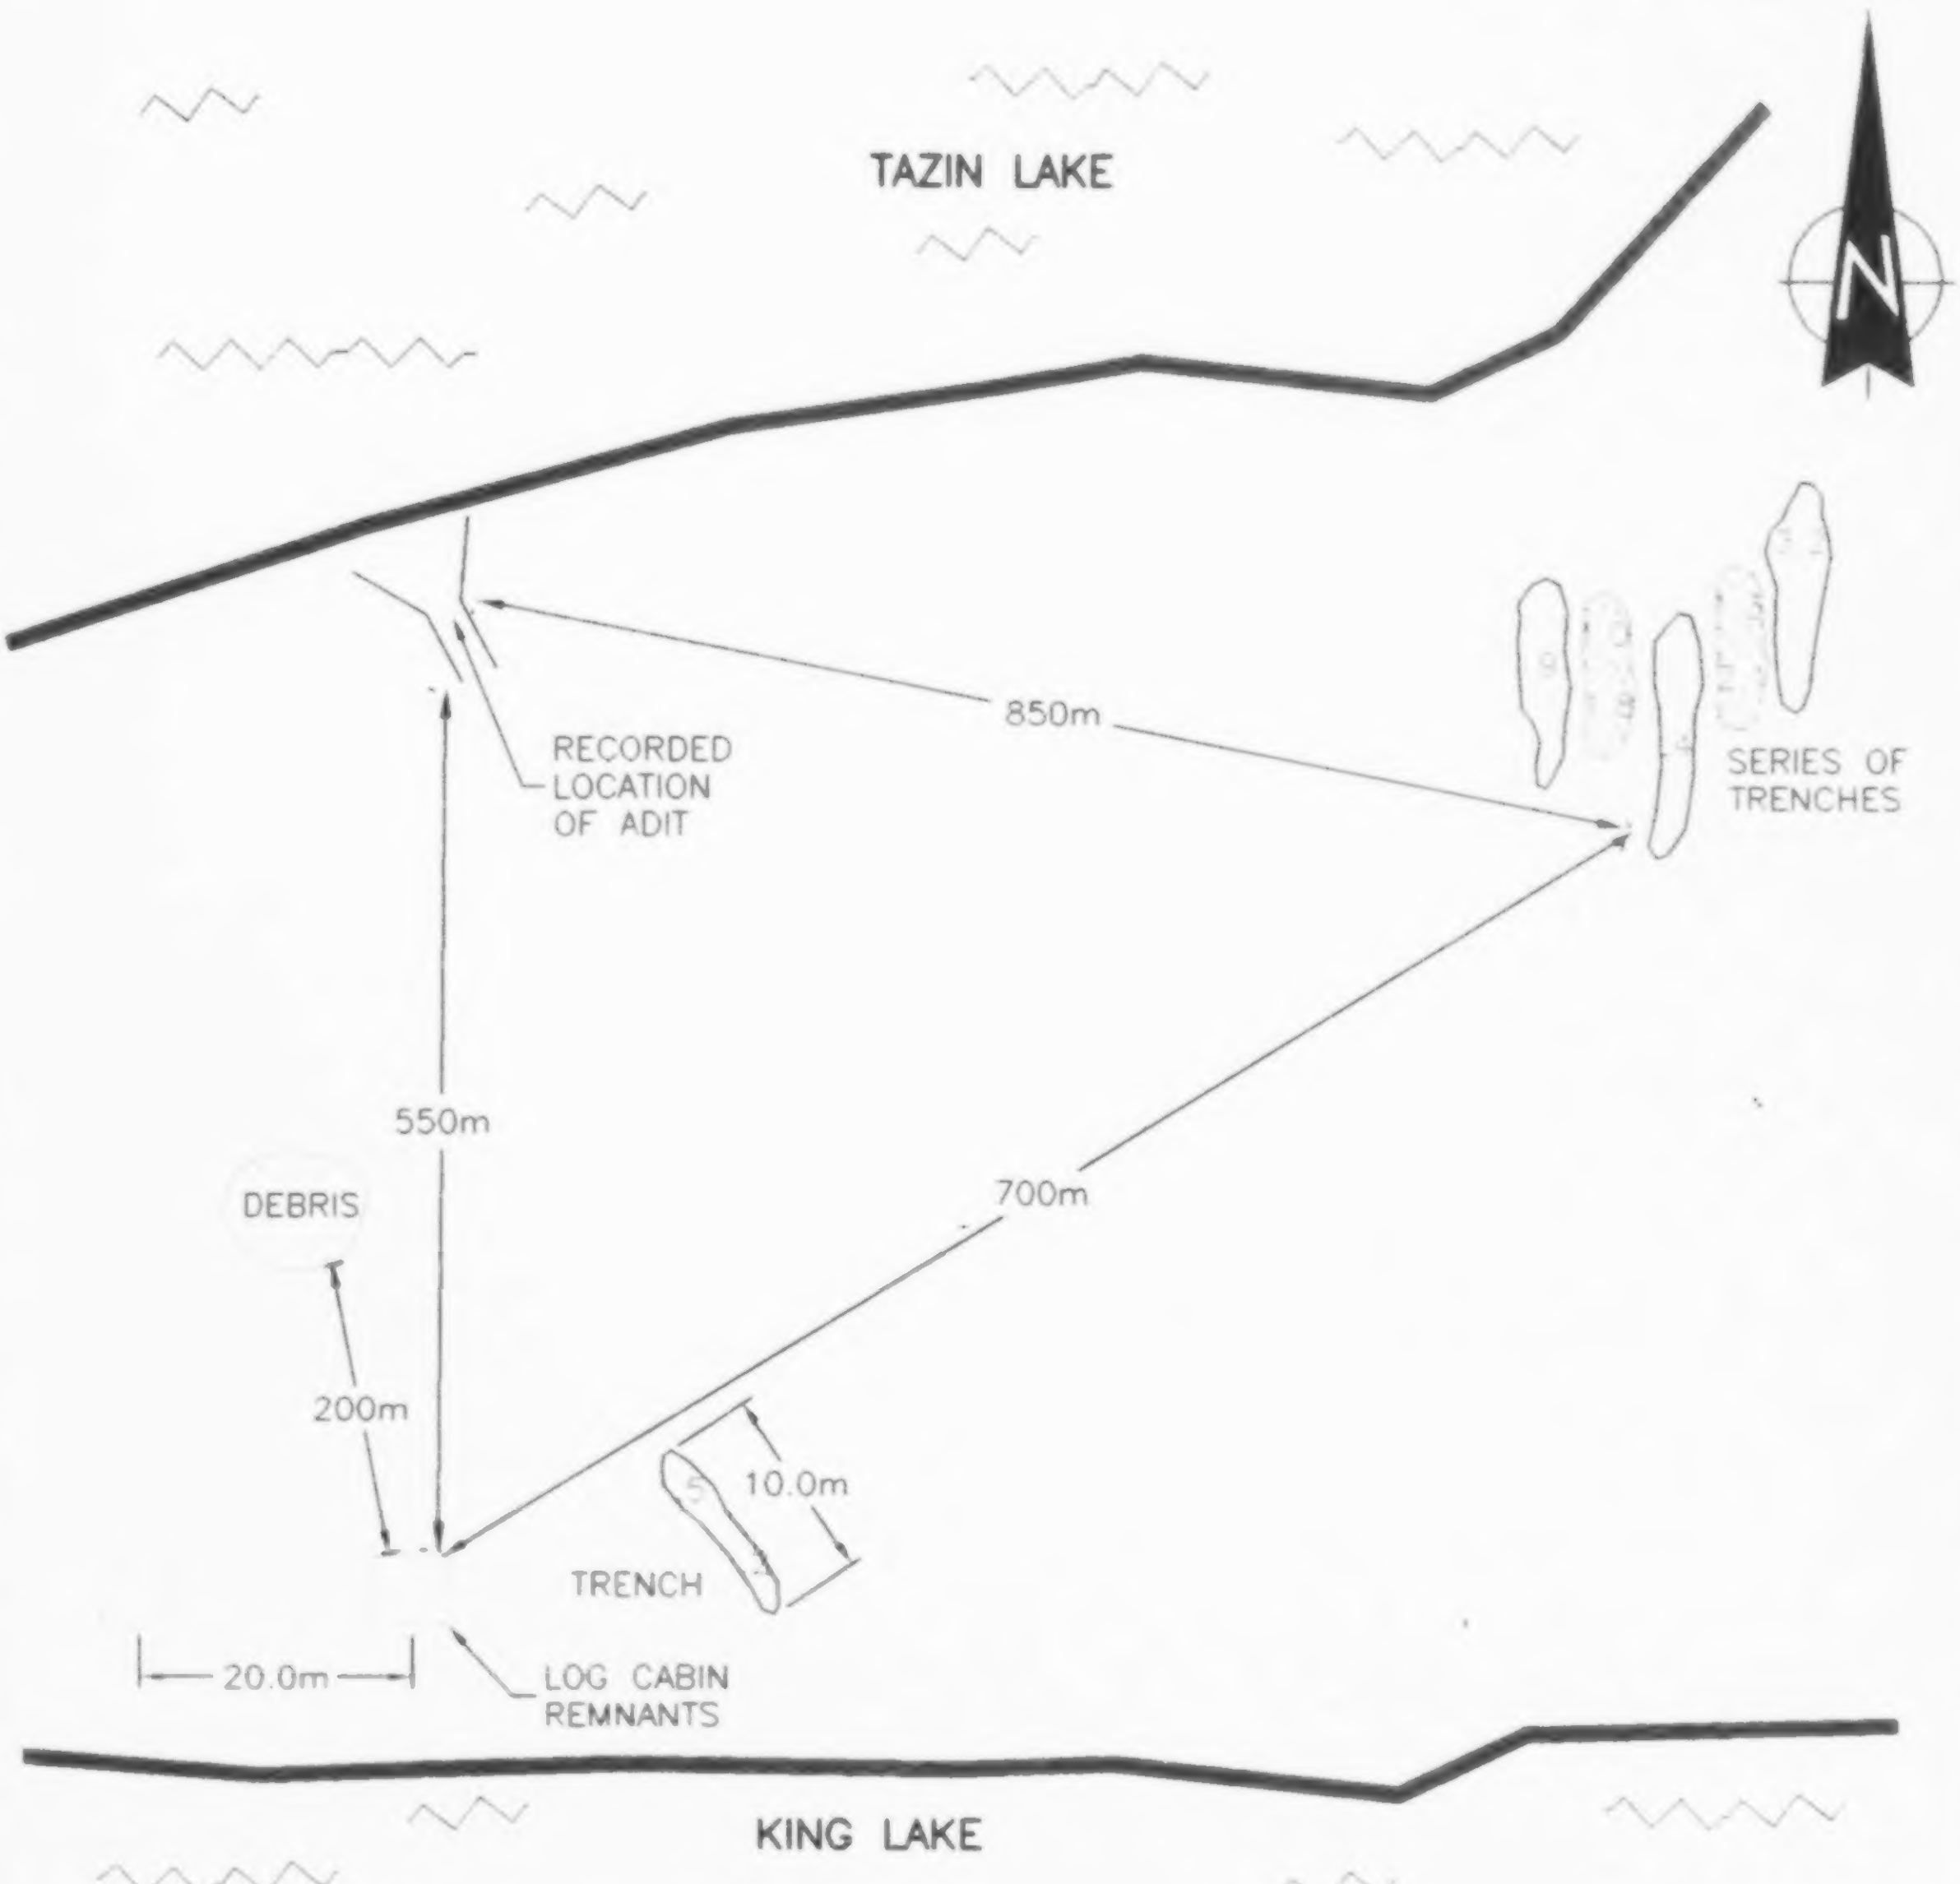
CLIFTON ASSOCIATES LTD. PROJECT NO: R3278 FIGURE NO: 6.2–2

The adit is located on the northwest shore of Laind Island (Figure 6.2-1). The adit is located about 500 m north of the abandoned camp (Figure 6.2-2). Photograph Nos. 6.2-1 and 6.2-2 show the site.

TAZIN LAKE
N
RECORDED LOCATION OF ADIT
850m
SERIES OF TRENCHES
9
550m
DEBRIS
700m
200m
10.0m
5
TRENCH
20.0m
LOG CABIN REMNANTS
KING LAKE

Follow-up work should include pushing debris into the adit and blasting it shut or sealing the adit with a secure metal or concrete cover.

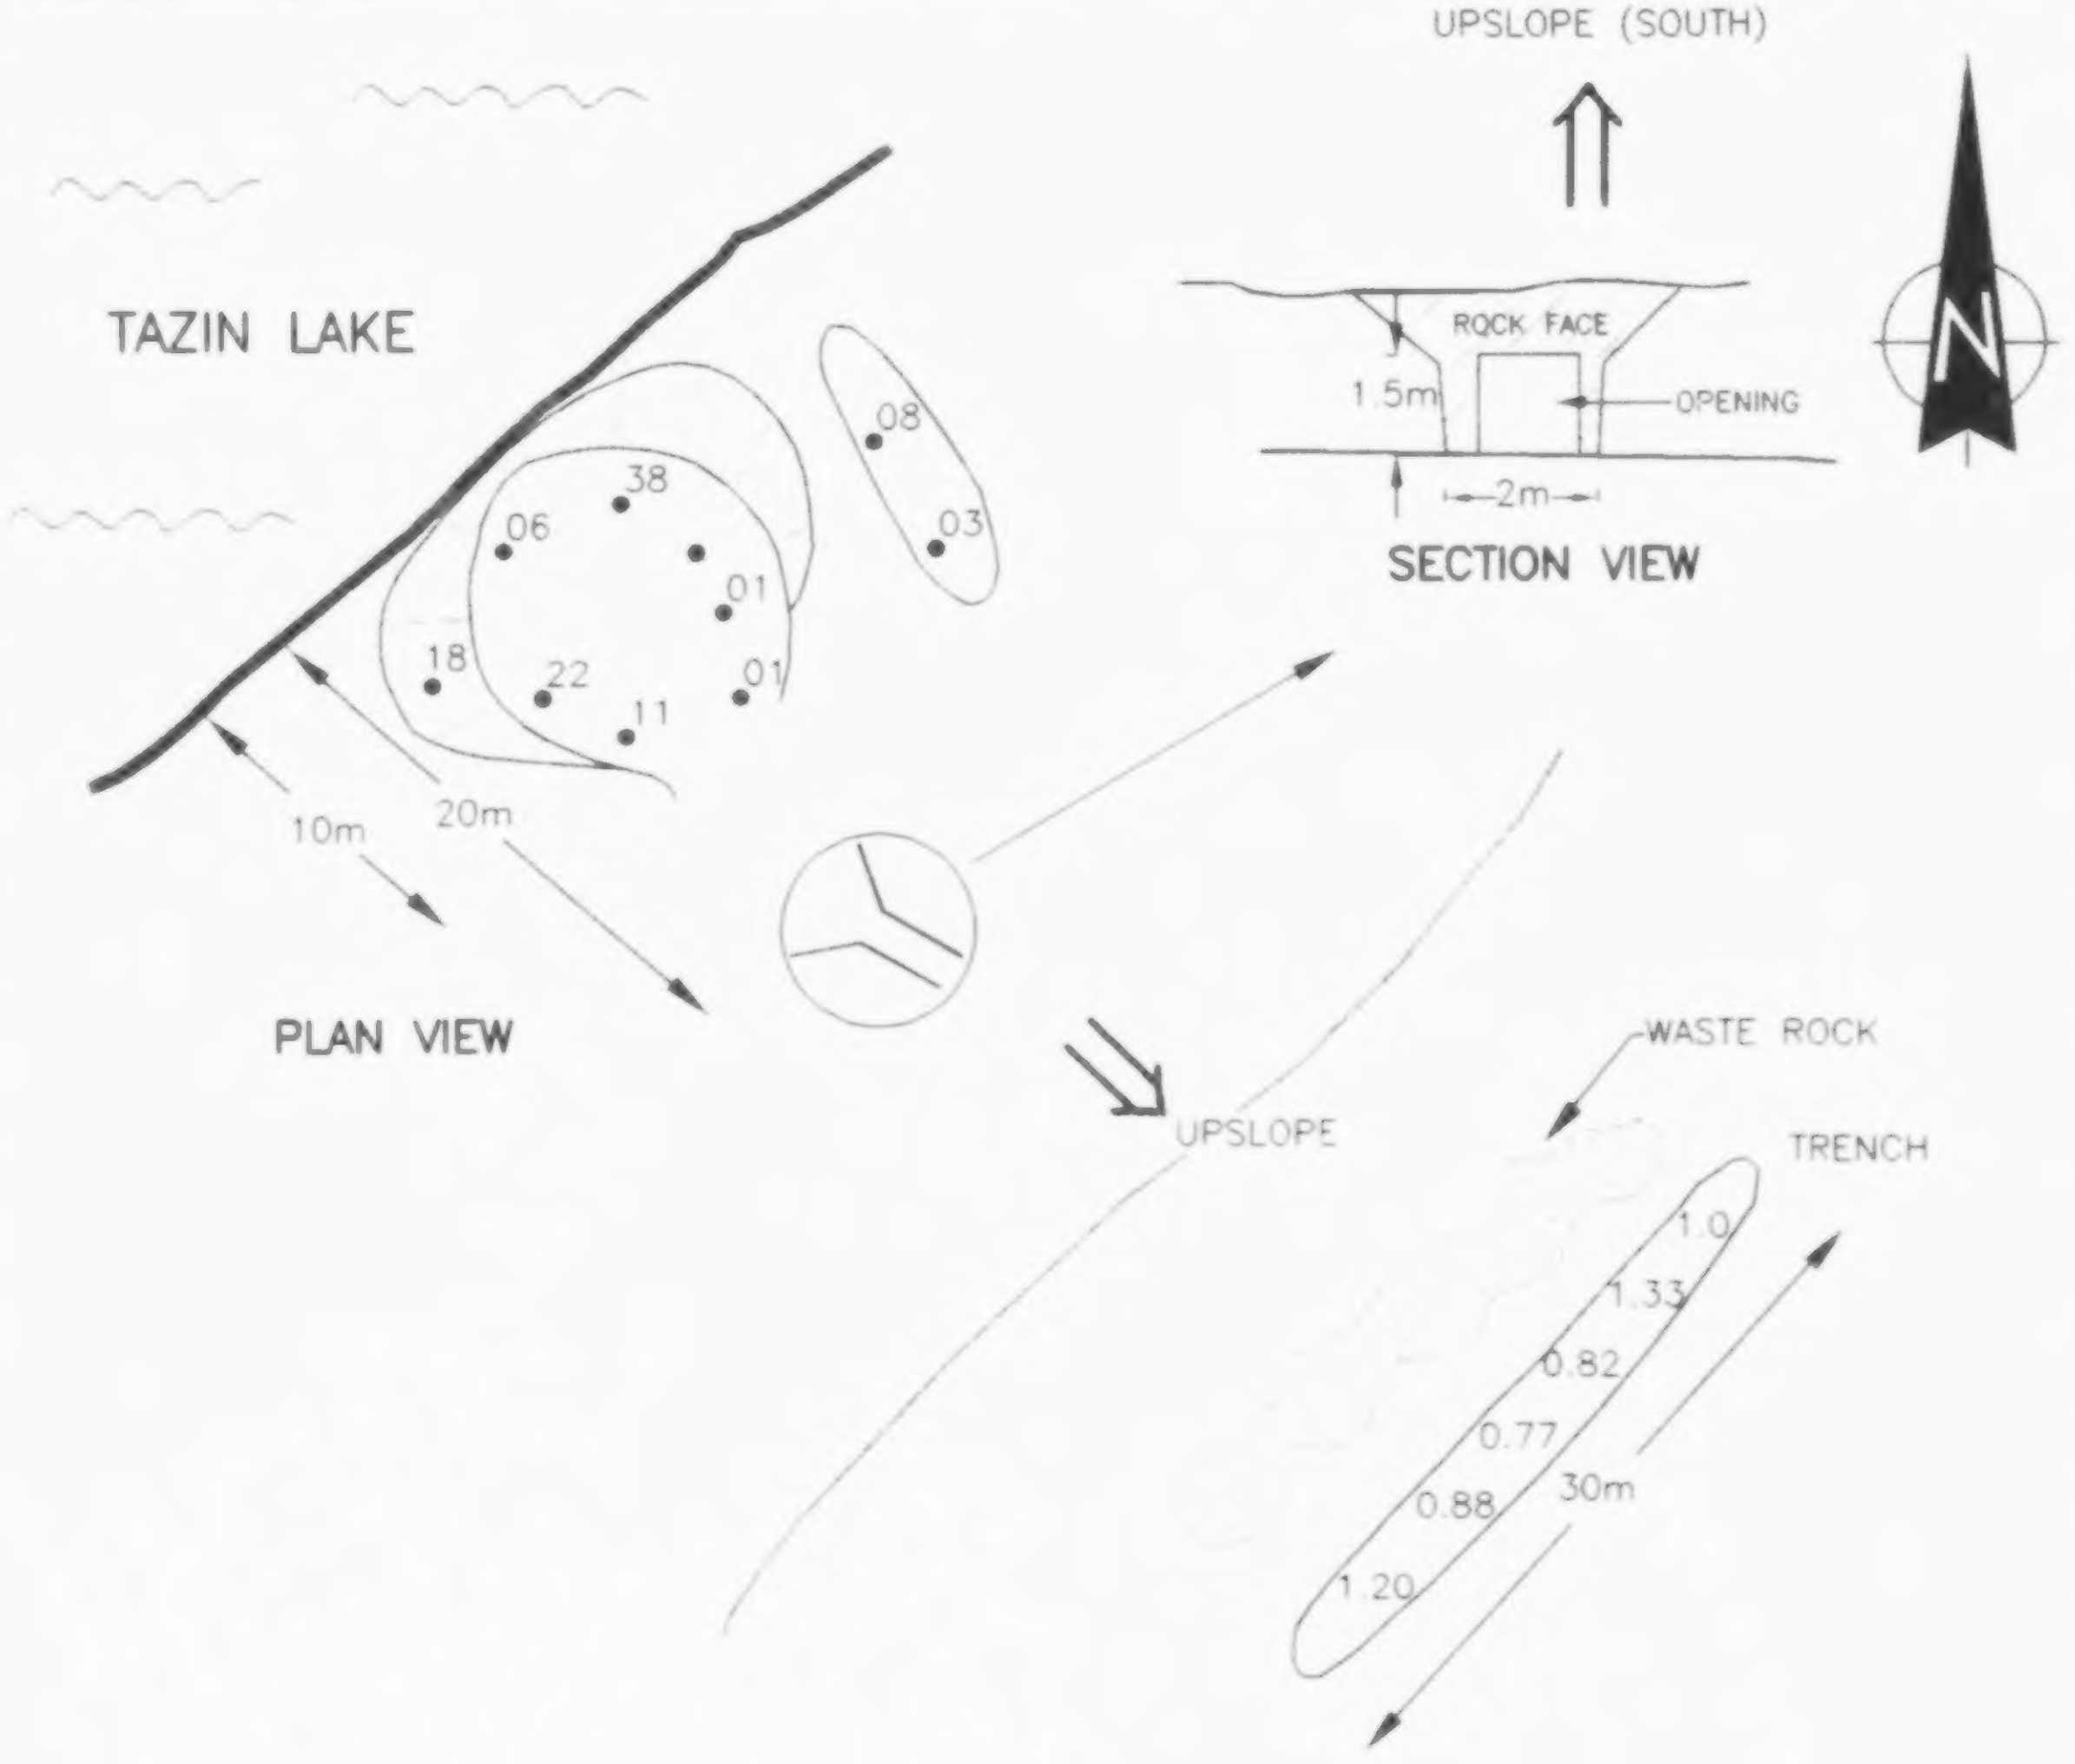
R3278/FIG6.2–3.DWG

UPSLOPE (SOUTH)
TAZIN LAKE
ROCK FACE
1.5m
OPENING
2m
SECTION VIEW
08
03
38
06
01
01
18
22
11
10m
20m
PLAN VIEW
UPSLOPE
WASTE ROCK
TRENCH
1.0
1.33
0.82
0.77
0.88
1.20
30m
N

About 300 m southwest of the adit is a large trench about 30 m long and 5 m wide. Associated with the trench is about 100 m^3 of waste rock. The gamma readings for the trench varied from .77 to 1.20 µSv/hr. There are no immediate hazards associated with the trench.

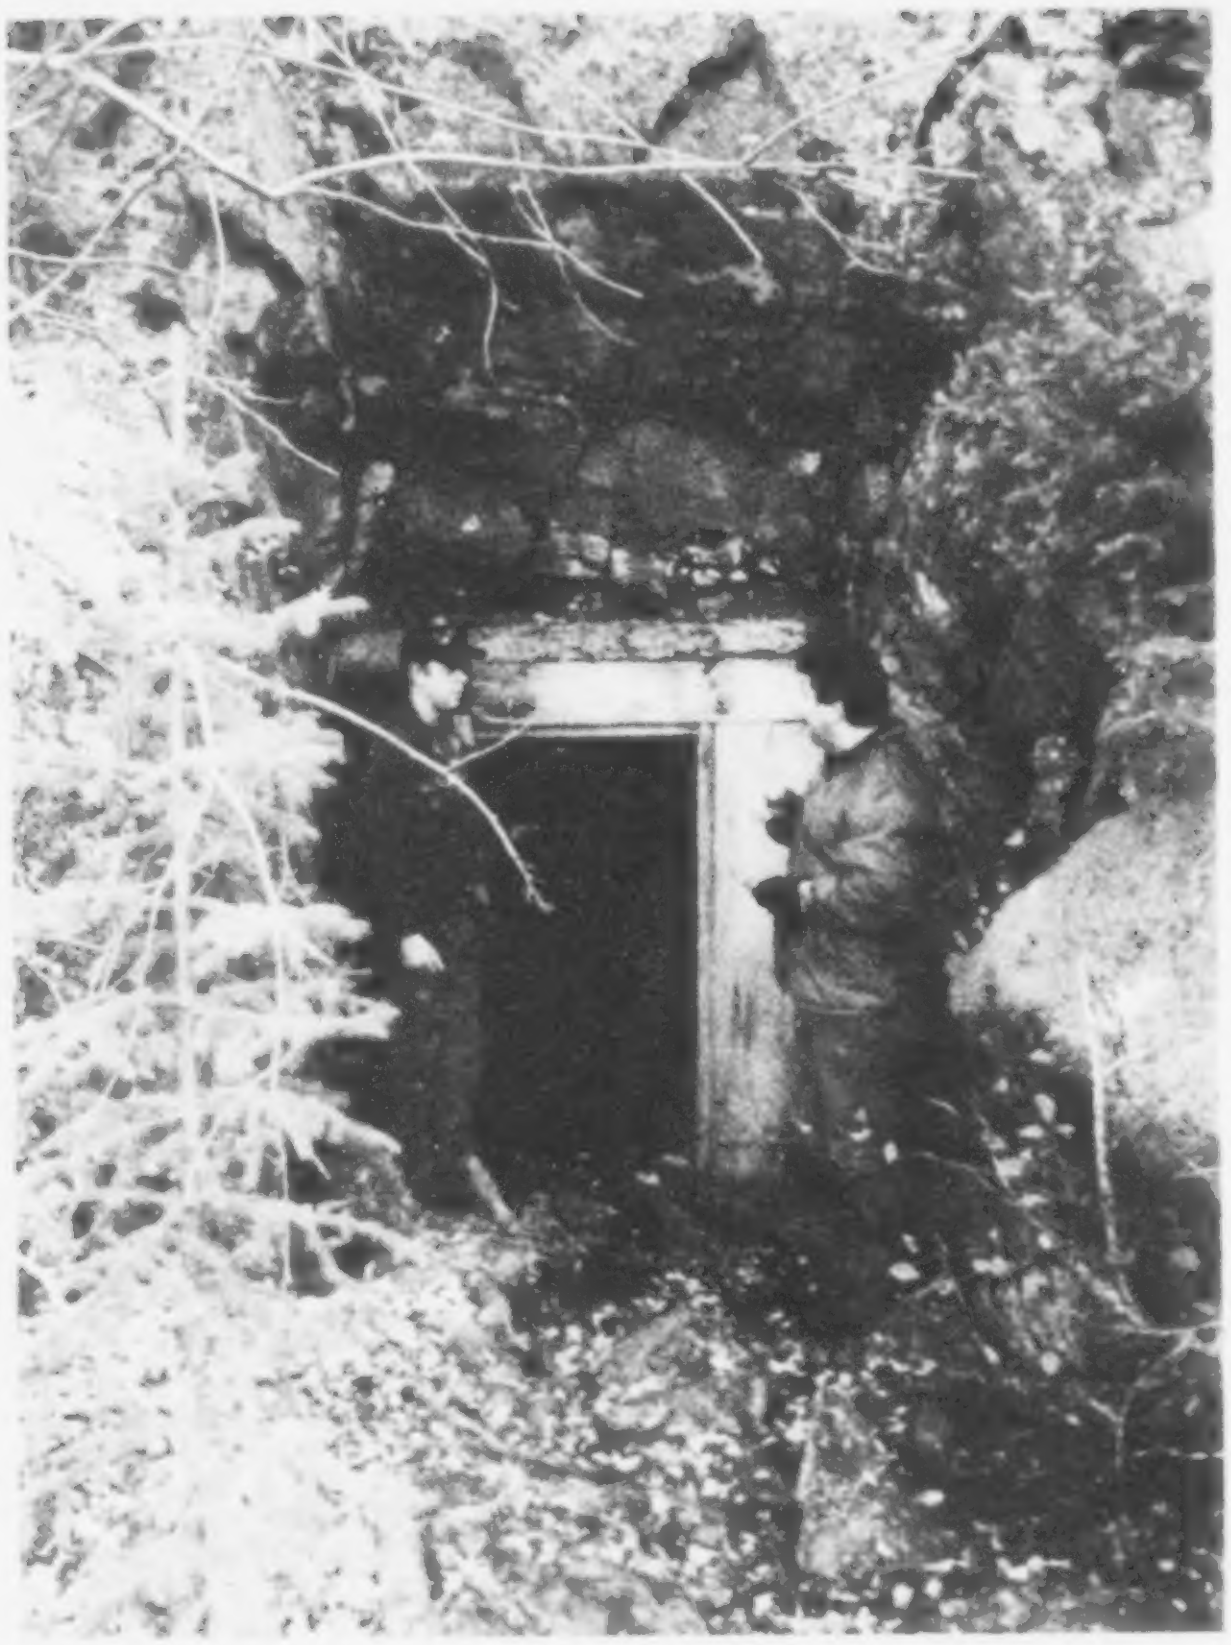
Photograph 6.2-1. New Mylamaque Site-Portal-September 30, 2002

The adit was open with about 20 m^3 of waste rock spread out toward Tazin Lake. There was no waste rock in the Lake. The waste rock did not have any visible sulphides or evidence of acid generation.

As part of the Year 2 assessment, certain assumptions were made regarding the adit in an attempt to provide a complete site assessment. It was assumed the adit was open with some stability problems, a small amount of water (intermittent) and waste rock located close to Tazin Lake. Based on the inspection of the adit, these assumptions were accurate. The ranking for the site will therefore remain unchanged from Year 2.

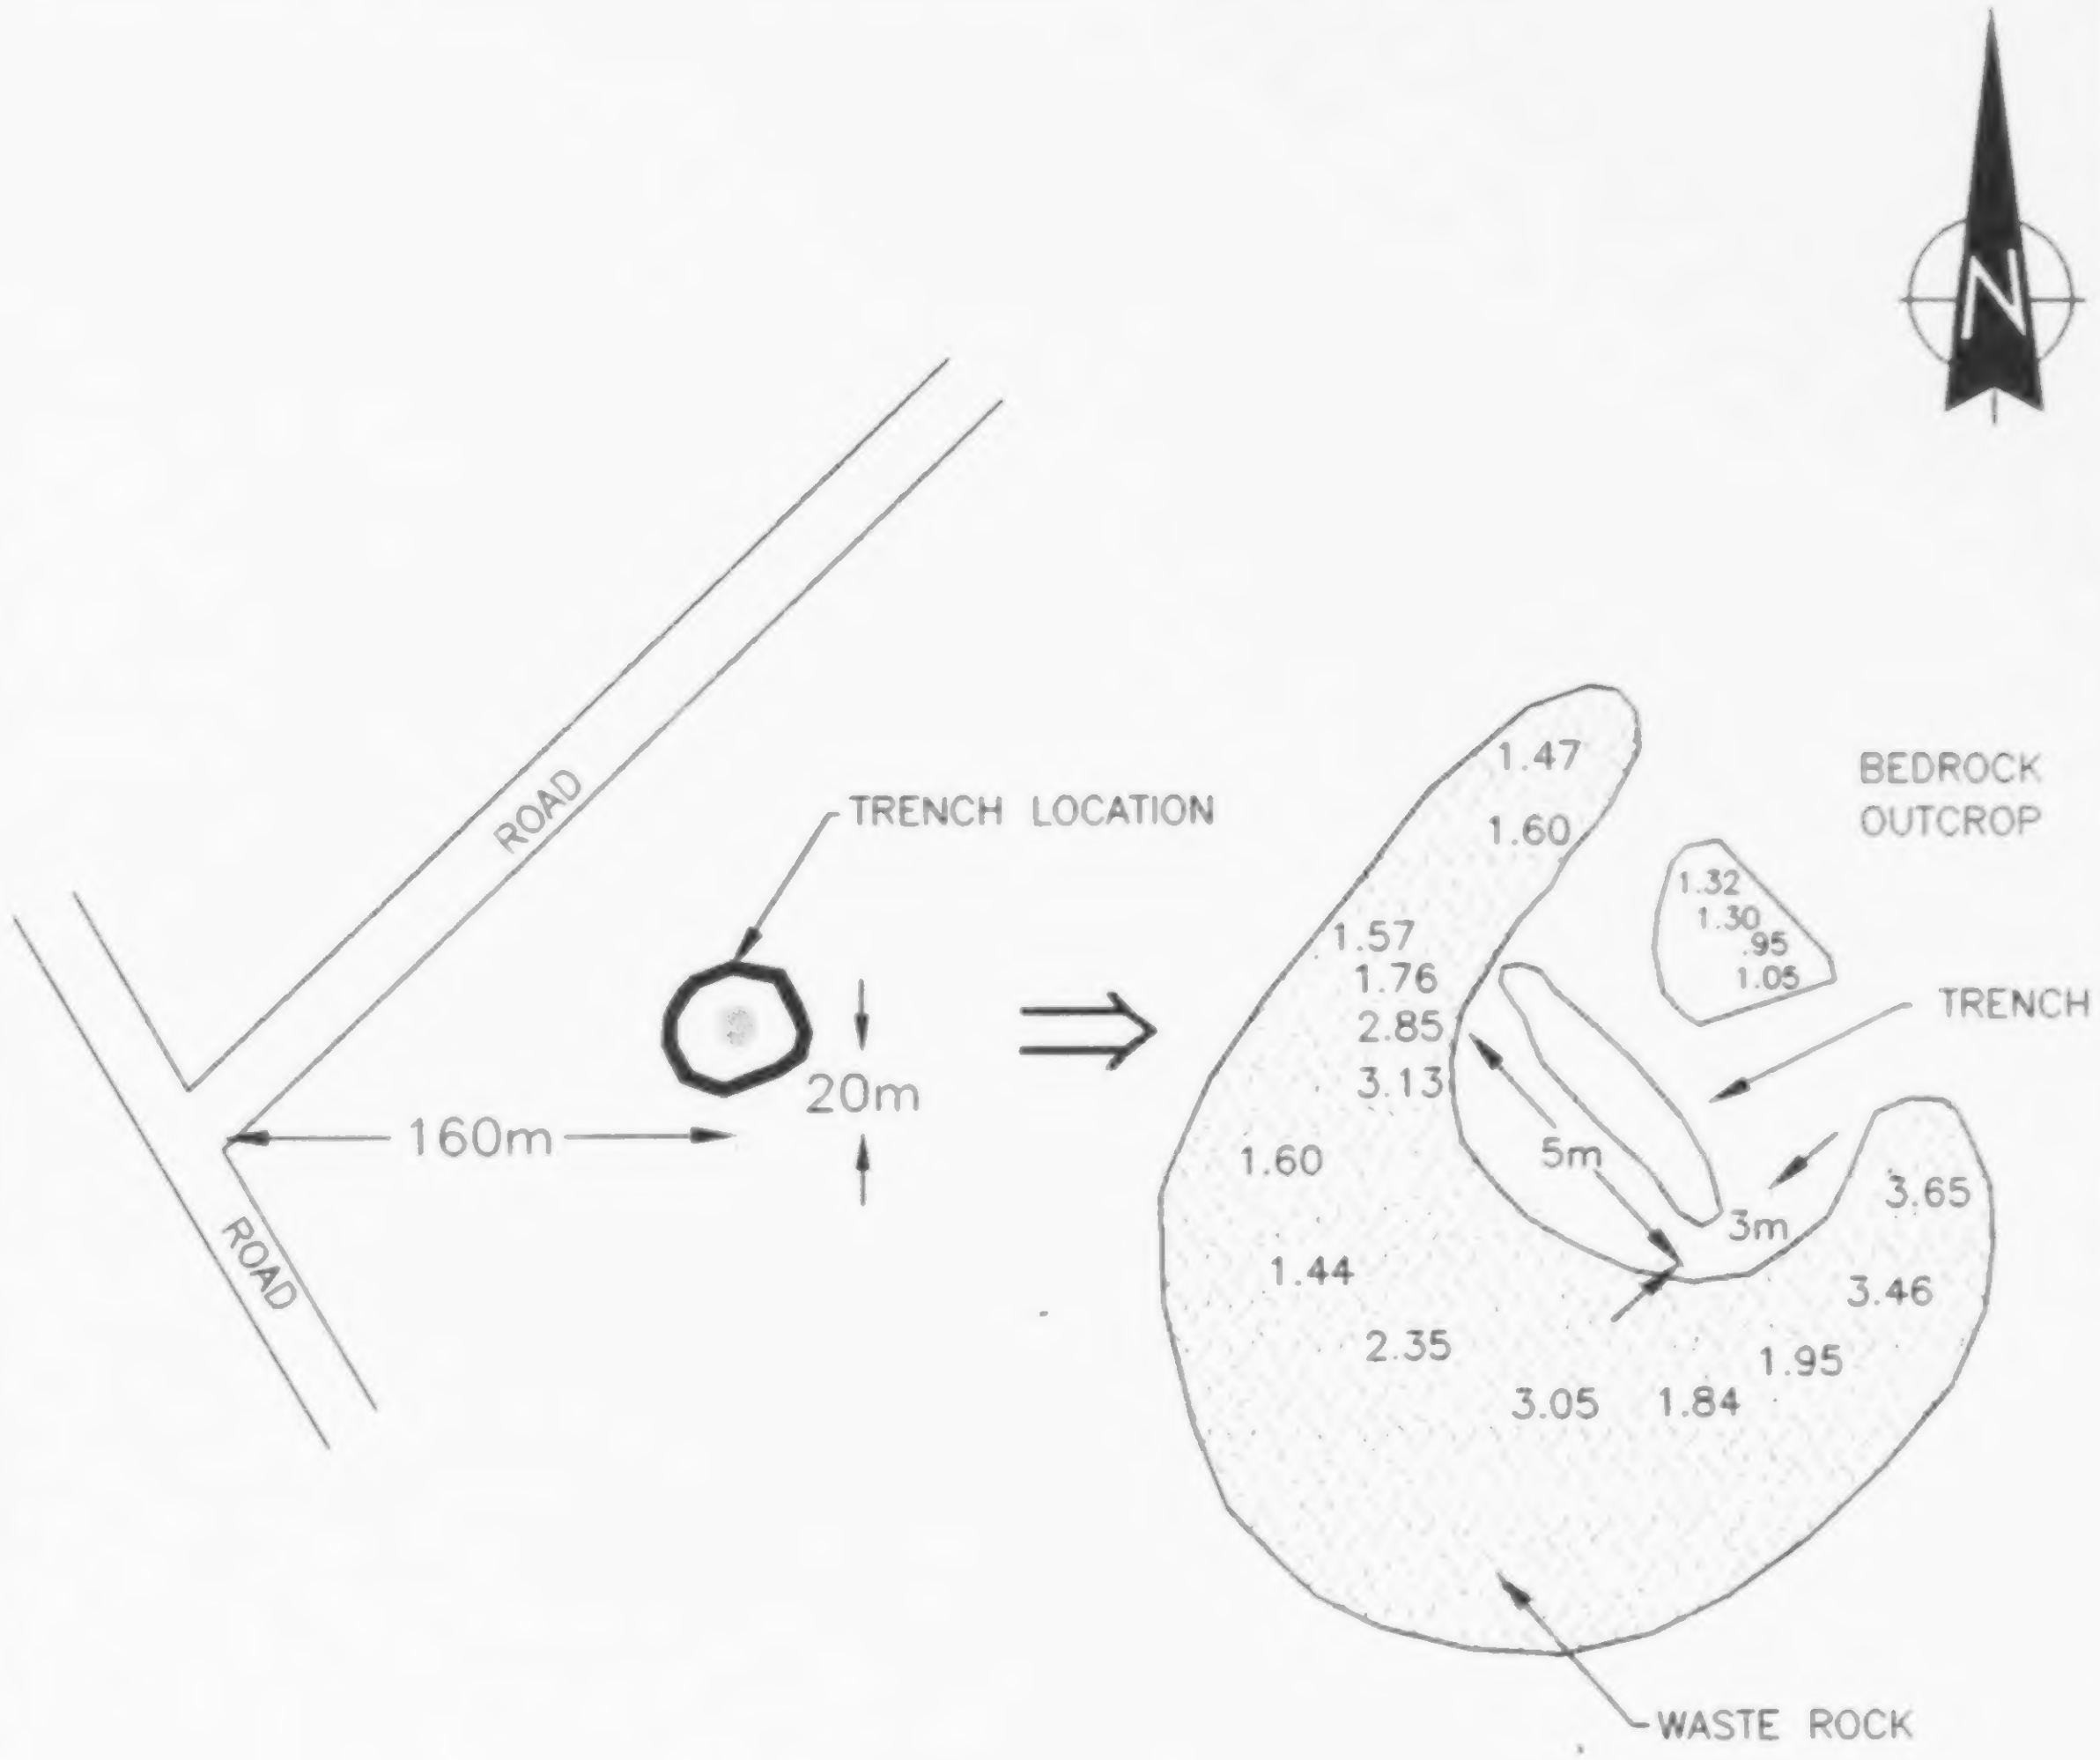
R3278/FIG6.3–2.DWG

Gamma values for the waste rock varied from 1.44 to 3.65 µSv/hr.

Given the presence of the trench and debris, the ranking of the site changes from a combined score of 4 to 10.

Follow-up work should focus on pushing waste rock and debris back into the trench to remove the public safety hazard and to reduce the gamma exposure present by the waste rock.

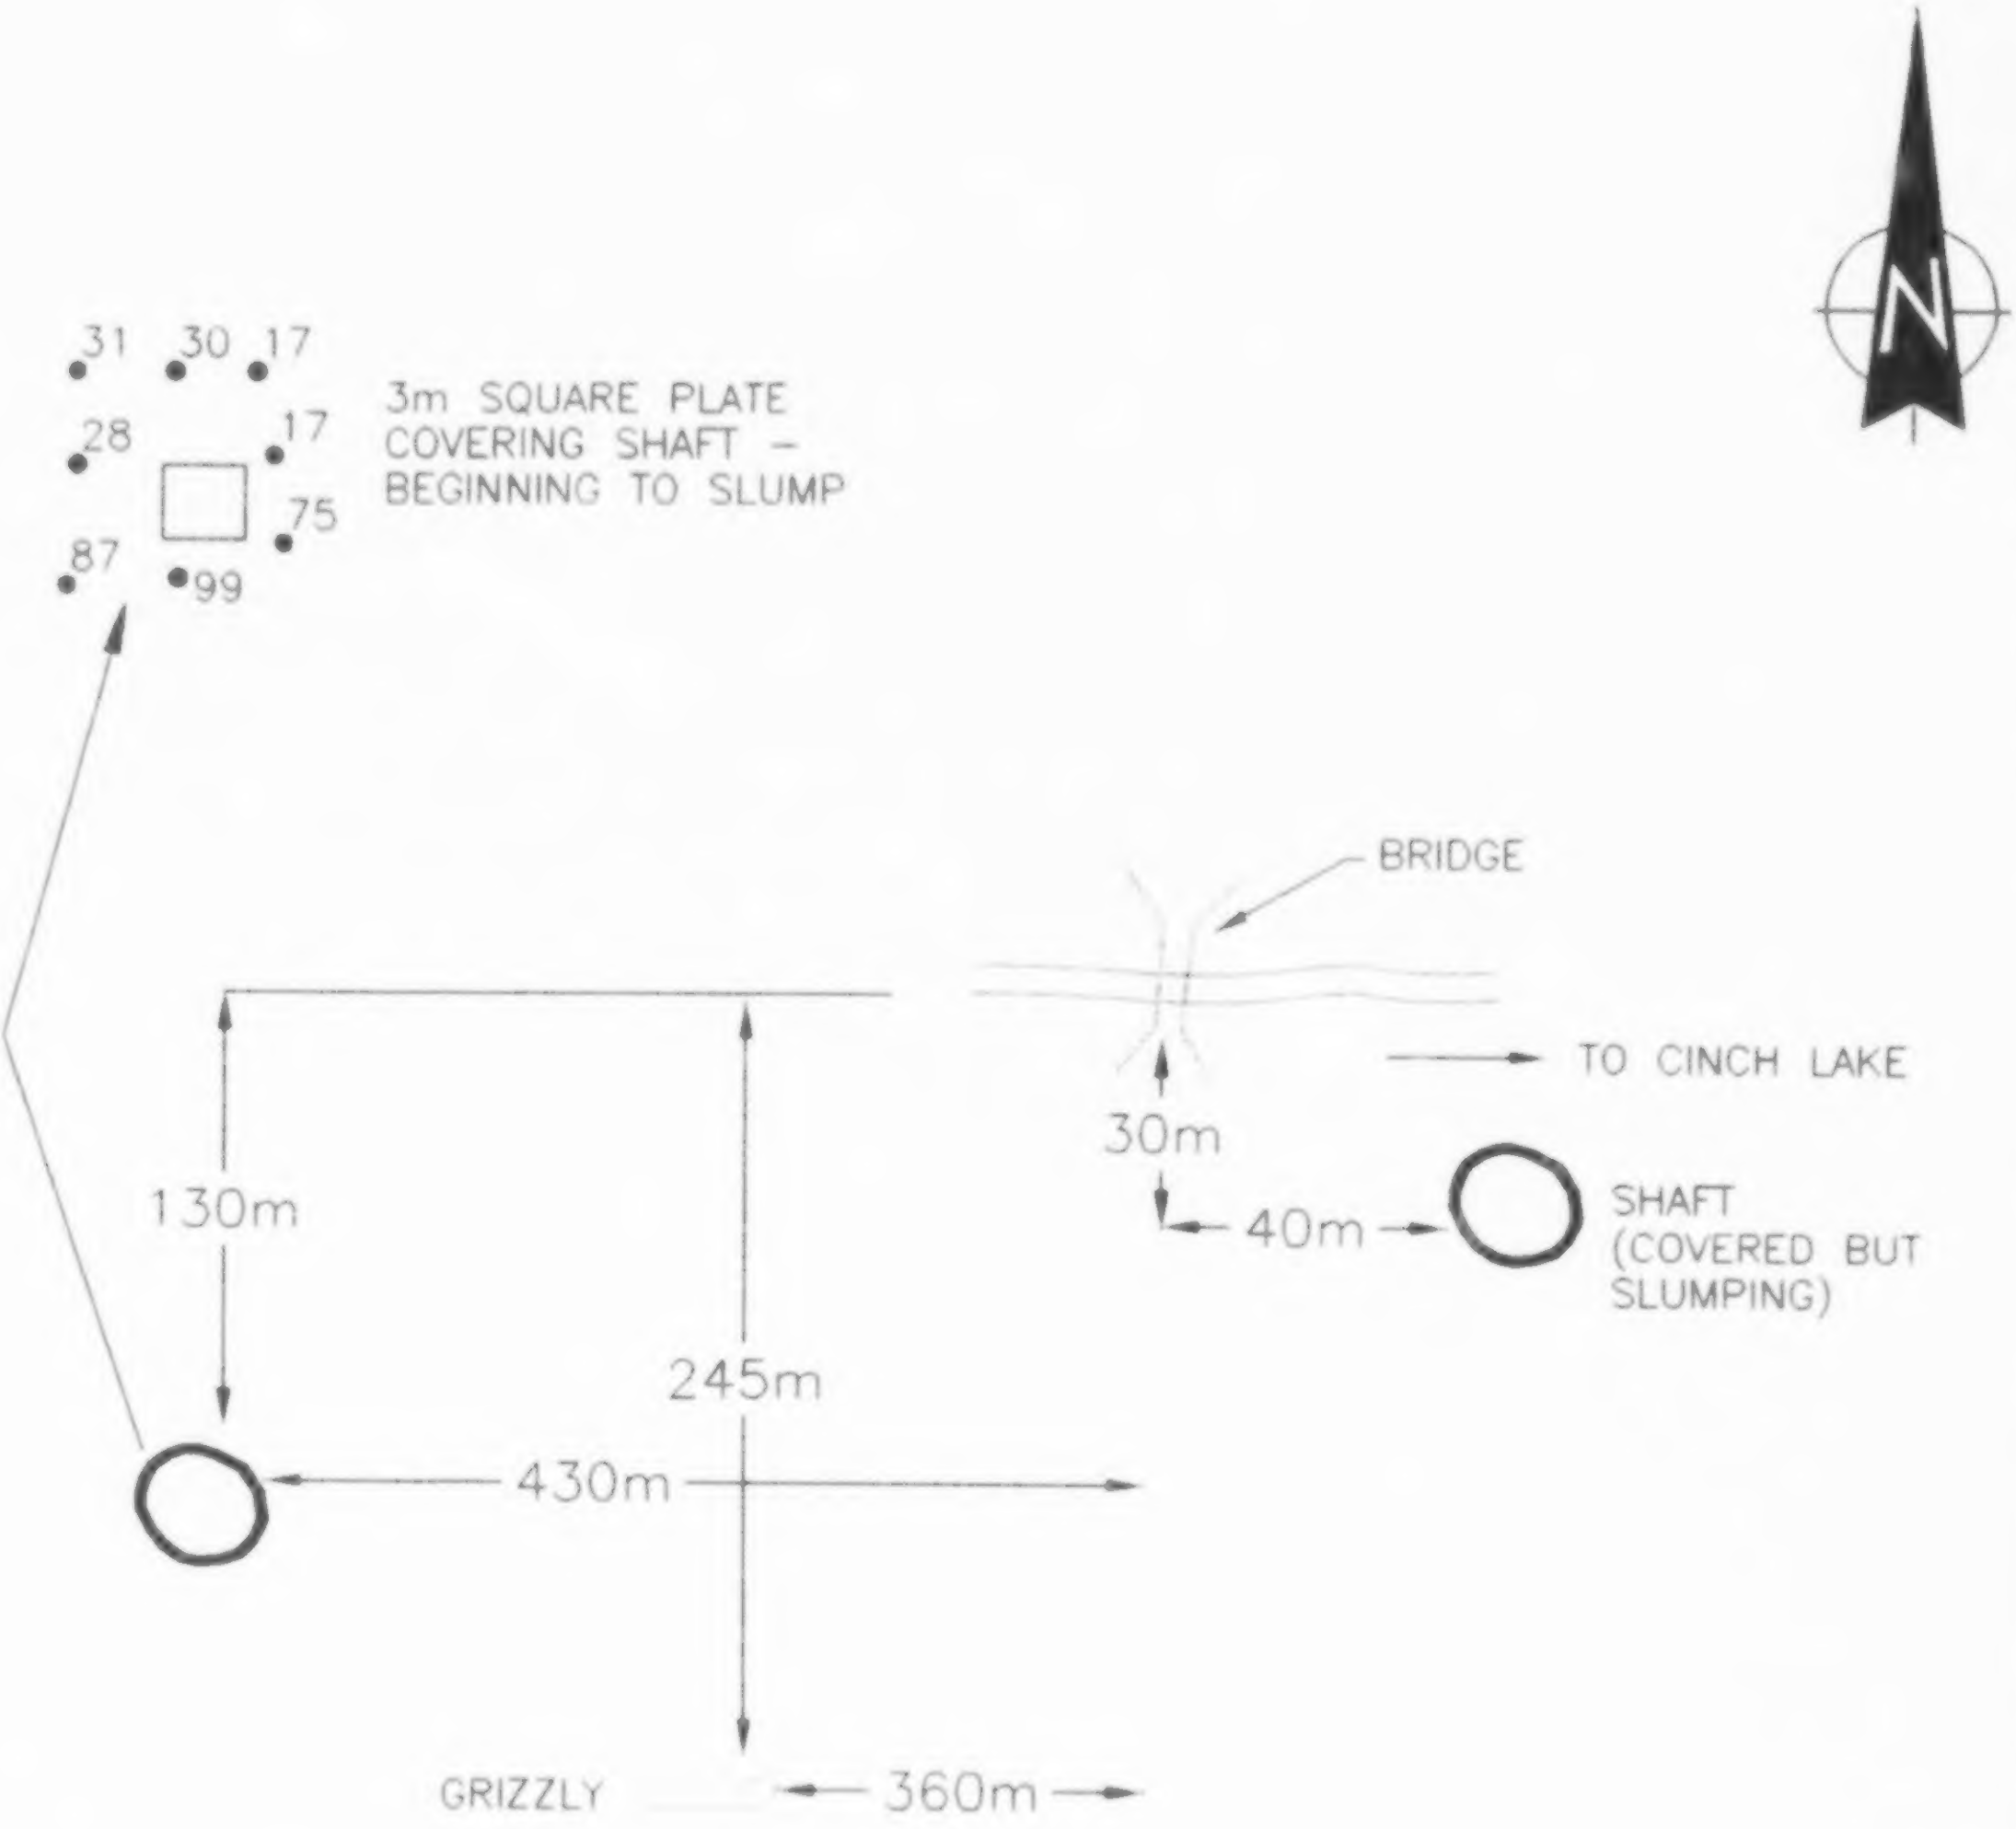
R32780/FIG6.4-2.DWG

Shaft No. 2 is slightly south of the bridge. This shaft is also opening and presents a public safety hazard.

N
31
30
17
28
17
75
87
99
3m SQUARE PLATE COVERING SHAFT – BEGINNING TO SLUMP
BRIDGE
TO CINCH LAKE
30m
40m
SHAFT (COVERED BUT SLUMPING)
130m
245m
430m
GRIZZLY
360m

Given the easy access to the site, work should focus on securing the shaft openings. This could be done by excavating existing material away and attracting secure concrete shaft covers on all these shaft openings
